ALERT SERVICE BULLETIN

Checking and replacing hinge pins on ailerons and elevator on the BW 600 aircraft

ASB BW 600XX 01

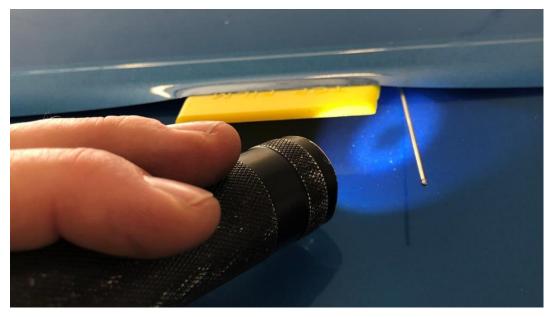
Bend rudder down and use a 1.5mm Allen wrench to push the end of the pin in each direction to make sure the deformation of the hinge is sufficient to stop the hinge pin from coming out in both directions.

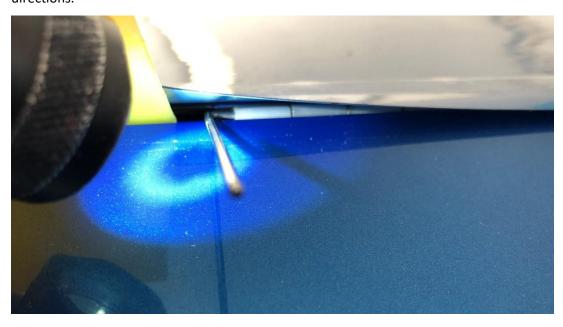
Make sure pin is not visible outside of any end of the eight hinges.

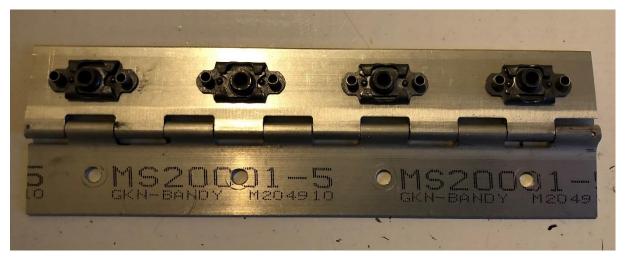
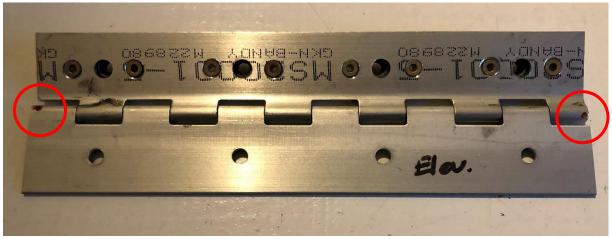
The cadmium plated steel pins for the elevator and aileron hinges has insufficient locking.

Figure 1. Removed hinge with faulty locking of hinge pin. Area marked that needs to be drilled out (about 5mm)

- 1. Push the hinge pin to one side and drill out the deformation on the other side using a 2.5mm drill bit. About 5mm depth, see figure 1.
- 2. Carefully push/hammer the pin out of the hinge using a mandrel tool (or similar)
- 3. Drill out the other side of the hinge

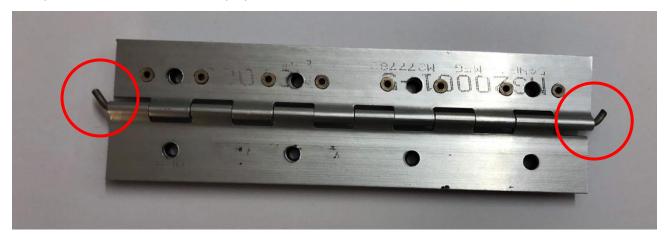
Figure 2. New hinge with correct locking of hinge pin according to HT_ASM_ULS_004_01_02 below (Appendix A)

- 4. Insert new lubricated pin
- 5. Bend the non-bent end using a plier or similar according **HT_ASM_ULS_004_02** below (Appendix A)

*The end of the steel-pin, that is not bent, needs to be bent by the owner or an aircraft mechanic after it is lubricated and inserted in the hinge. The hinge shall not be mounted on the plane to ease the operation. A few millimeters of play back and forward are recommended to avoid friction.
