AEROPRAKT SERVICE BULLETIN

No. SB A32-22

WINDSHIELD GLASS REPLACEMENT ON A32 AND A32L AIRPLANES

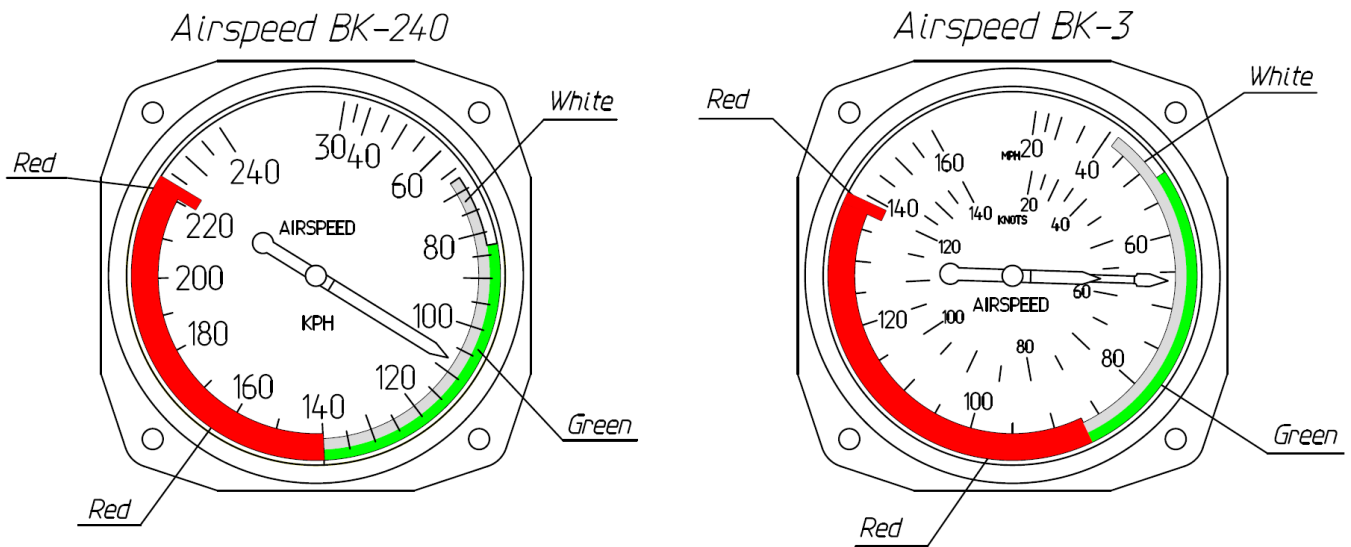
Fig. 1

Operational experience with a 2 mm thick PETG windshield has shown that this material, when used for a long time (more than 5 years), is prone to cracking, which can subsequently lead to the destruction of the windshield in flight.

2.1) Before replacing the windshield, put a temporary red speed limit sector $V_{ne} = 140 \text{ km/h}$ (87 mph) to the airspeed indicator (see Fig. 1) and mark this temporary speed limitation in the relevant section of the POH (in any convenient way, for example, with a red pencil).
