AEROPRAKT SERVICE BULLETIN

No. SB A32-23

WINDSHIELD GLASS REPLACEMENT ON A32 AIRPLANES

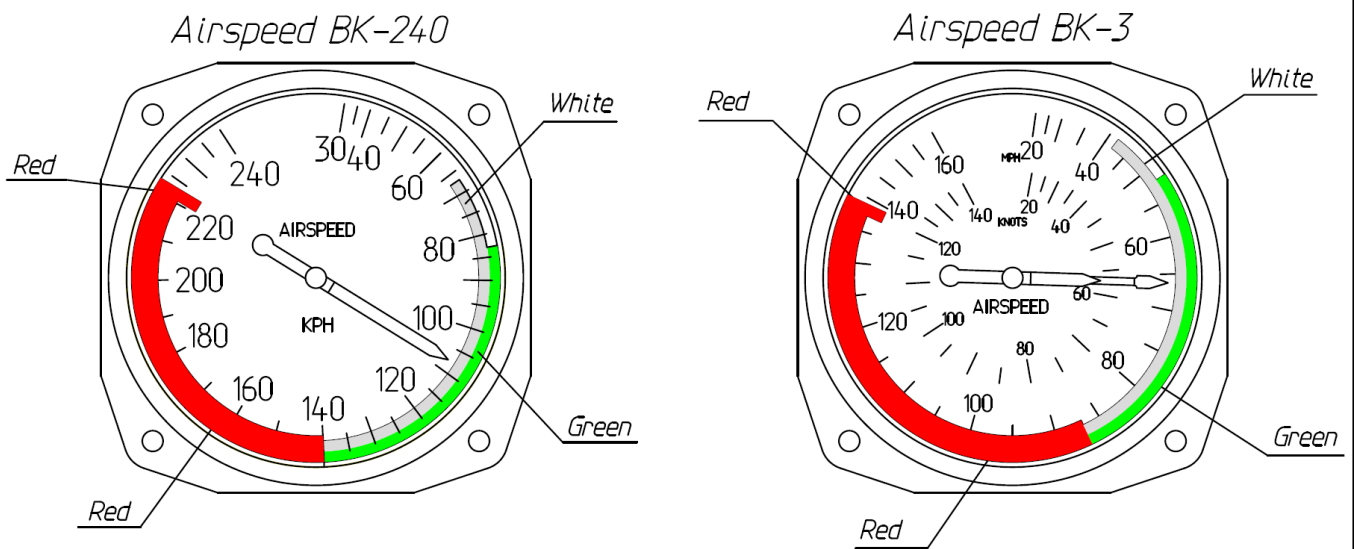
Fig. 1

Operational experience with the windshields made of 3 mm thick acrylic glass on the aircraft affected by this service bulletin has shown that the the windshield material is prone to cracking after some period of time. This may cause the windshield collapse in flight.

2.1) Before replacing the windshield, put a temporary red speed limit sector $V_{ne} = 140$ km/h (87 mph) to the airspeed indicator (see Fig. 1) and mark this temporary speed limit in the relevant section of the POH (in any convenient way, for example, with a red pencil).
