ALERT SERVICE BULLETIN

Checking and replacing hinge pins on ailerons and elevator on the BW 600 aircraft

ASB BW 600XX 01

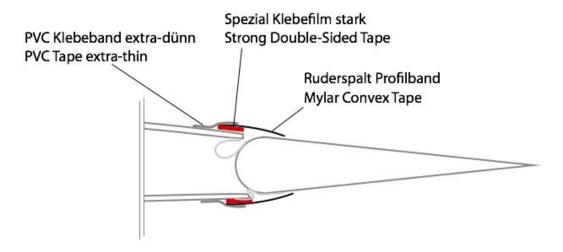
Figure 3. Typical installation of speed tape. PVC Tape in figure is replaced by colored wrapping foil provided by BLACKWING.

- 1. Clean area where speed tape shall attach with a degreasing agent
- 2. Install 12 mm double sided tape
- 3. Install 25mm curved mylar
- 4. Secure with provided 30mm wide wrapping foil (also covering the white mylar)
- 5. Use a heat gun carefully to increase the adhesion of the provided colored foil
